**DEPARTMENT OF TRANSPORTATION****DIVISION OF ENGINEERING SERVICES**

Office of Structural Materials

Contract #: 04-0120F4Cty: SF/ALA Rte: 80 PM: 13.2/13.9File #: 69.28**WELDING INSPECTION REPORT****Resident Engineer:** Pursell, Gary**Address:** 333 Burma Road**City:** Oakland, CA 94607**Report No:** WIR-009680**Date Inspected:** 11-Oct-2009**Project Name:** SAS Superstructure**OSM Arrival Time:** 700**Prime Contractor:** American Bridge/Fluor Enterprises, a JV**OSM Departure Time:** 1900**Contractor:** Zhenhua Port Machinery Company, Ltd (ZPMC), Changxing Island **Location:** Shanghai, China**CWI Name:** ZPMC and ABF**CWI Present:** Yes No**Inspected CWI report:** Yes No N/A**Rod Oven in Use:** Yes No N/A**Electrode to specification:** Yes No N/A**Weld Procedures Followed:** Yes No N/A**Qualified Welders:** Yes No N/A**Verified Joint Fit-up:** Yes No N/A**Approved Drawings:** Yes No N/A**Approved WPS:** Yes No N/A**Delayed / Cancelled:** Yes No N/A**Bridge No:** 34-0006**Component:** OBG**Summary of Items Observed:**

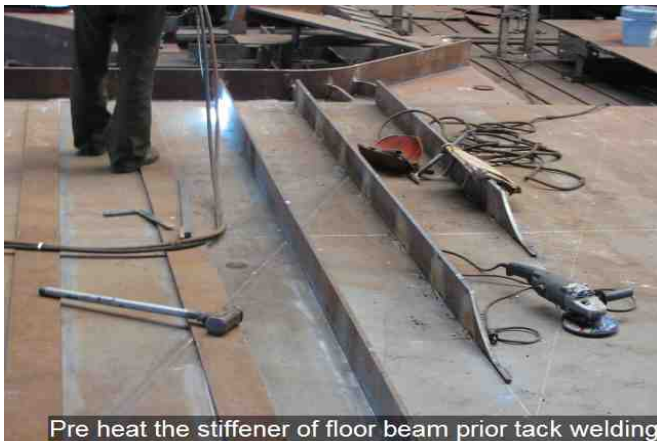
up and SMAW tack weld process on the stiffeners of floor beam type 3 ID# FB 3054-001 and FB3056-001. A numerous temporary tack welds have been welded attach to the stiffeners after pre heat completed on the tack weld areas. The fit up and SMAW tack welding process were monitored and recorded by ZPMC and ABF QC inspector. Base on Caltrans QAI observation, no discrepancies were noted.

Pre heat the stiffener of floor beam prior tack welding

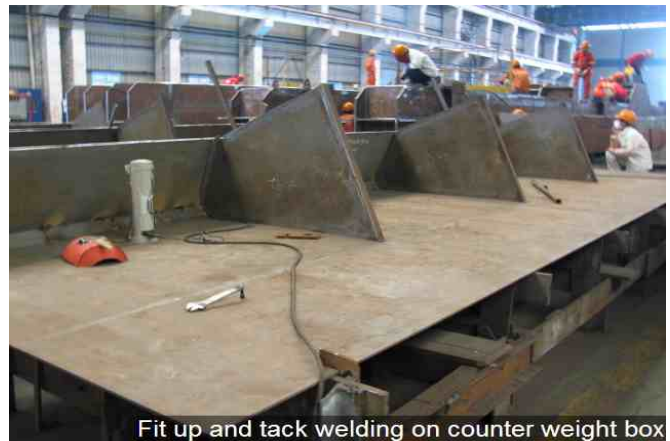
Counter weight box: - Caltrans QA inspector observed two ZPMC workers and one tack weld welder performed fit up and SMAW tack weld process on the base plates of counter weight box CW-92 and CW-86. A numerous temporary tack welds have been welded attach to the two plates after adjusted and secured by hand jack and clamps. The fit up and SMAW tack welding process were monitored and recorded by ZPMC and ABF QC inspector. Based on Caltrans QAI observation, no discrepancies were noted.

Fit up and tack welding on counter weight box

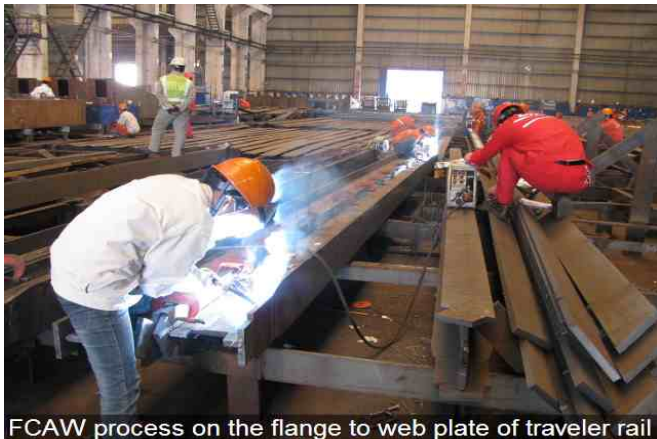
Traveler rails type TR10:- Caltrans QA inspector observed two ZPMC welders performed FCAW process on the flange to web plate of traveler rail #10TK3-008 and 10TK3-014. This type component designed has CJP and PJP weld along on one side of full weld length and other side has CJP only. The FCAW process were monitored and recorded by ZPMC and ABF QC inspector. Based on Caltrans QA Inspector observations, no discrepancies were noted.

FCAW process on the flange to web plate of traveler rail

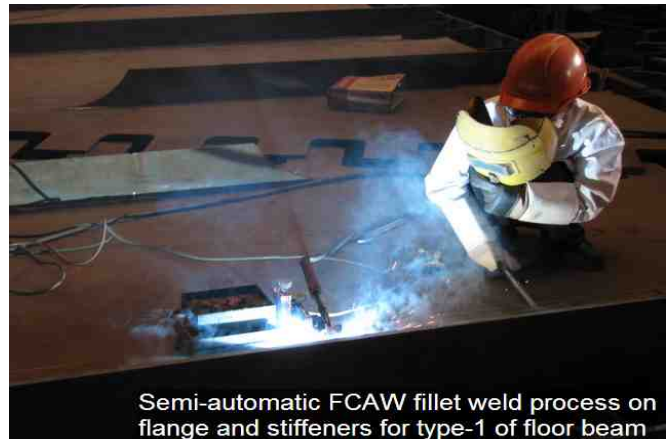
Floor beam type 1:- Caltrans QA inspector observed one ZPMC welding operator performed semi-automatic FCAW fillet weld process on flange and stiffeners for type-1 of floor beam #FB-3037-001. The fillet weld size is 6mm with single pass. The semi-automatic FCAW fillet welds process were monitored and recorded by ZPMC and ABF QC inspector. Based on Caltrans QA Inspector observations, no discrepancies were noted.

Semi-automatic FCAW fillet weld process on flange and stiffeners for type-1 of floor beam
